# **Sabbathday Lake Watershed Survey Report**

**Cumberland County Soil and Water Conservation District  
Sabbathday Lake Association  
Maine Department of Environmental Protection**

**April 2009**

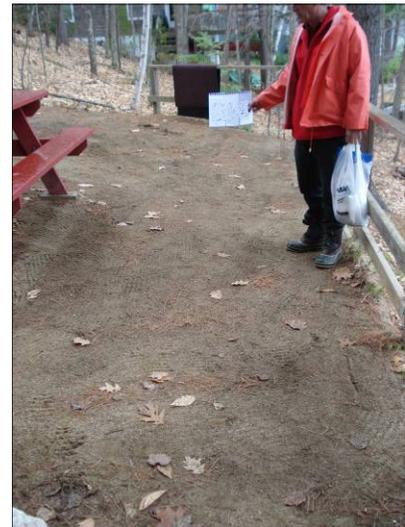
Raking removes the natural duff layer (pine needles, leaves, etc.), which results in increased runoff into the lake.

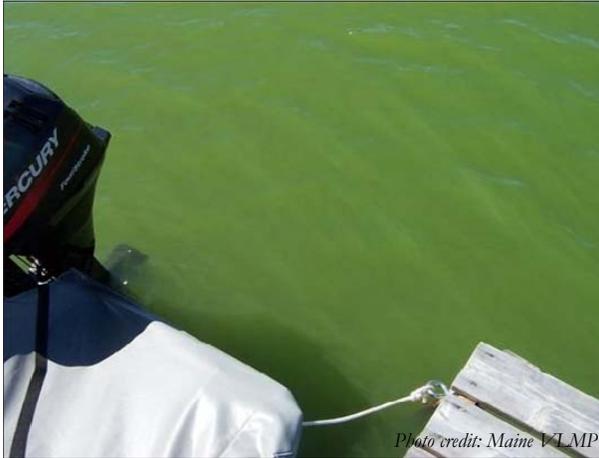
Excess **phosphorus** can “fertilize” a lake and lead to nuisance **algae blooms** like this one that occurred in 2002 on Pease Pond in Wilton, Maine.

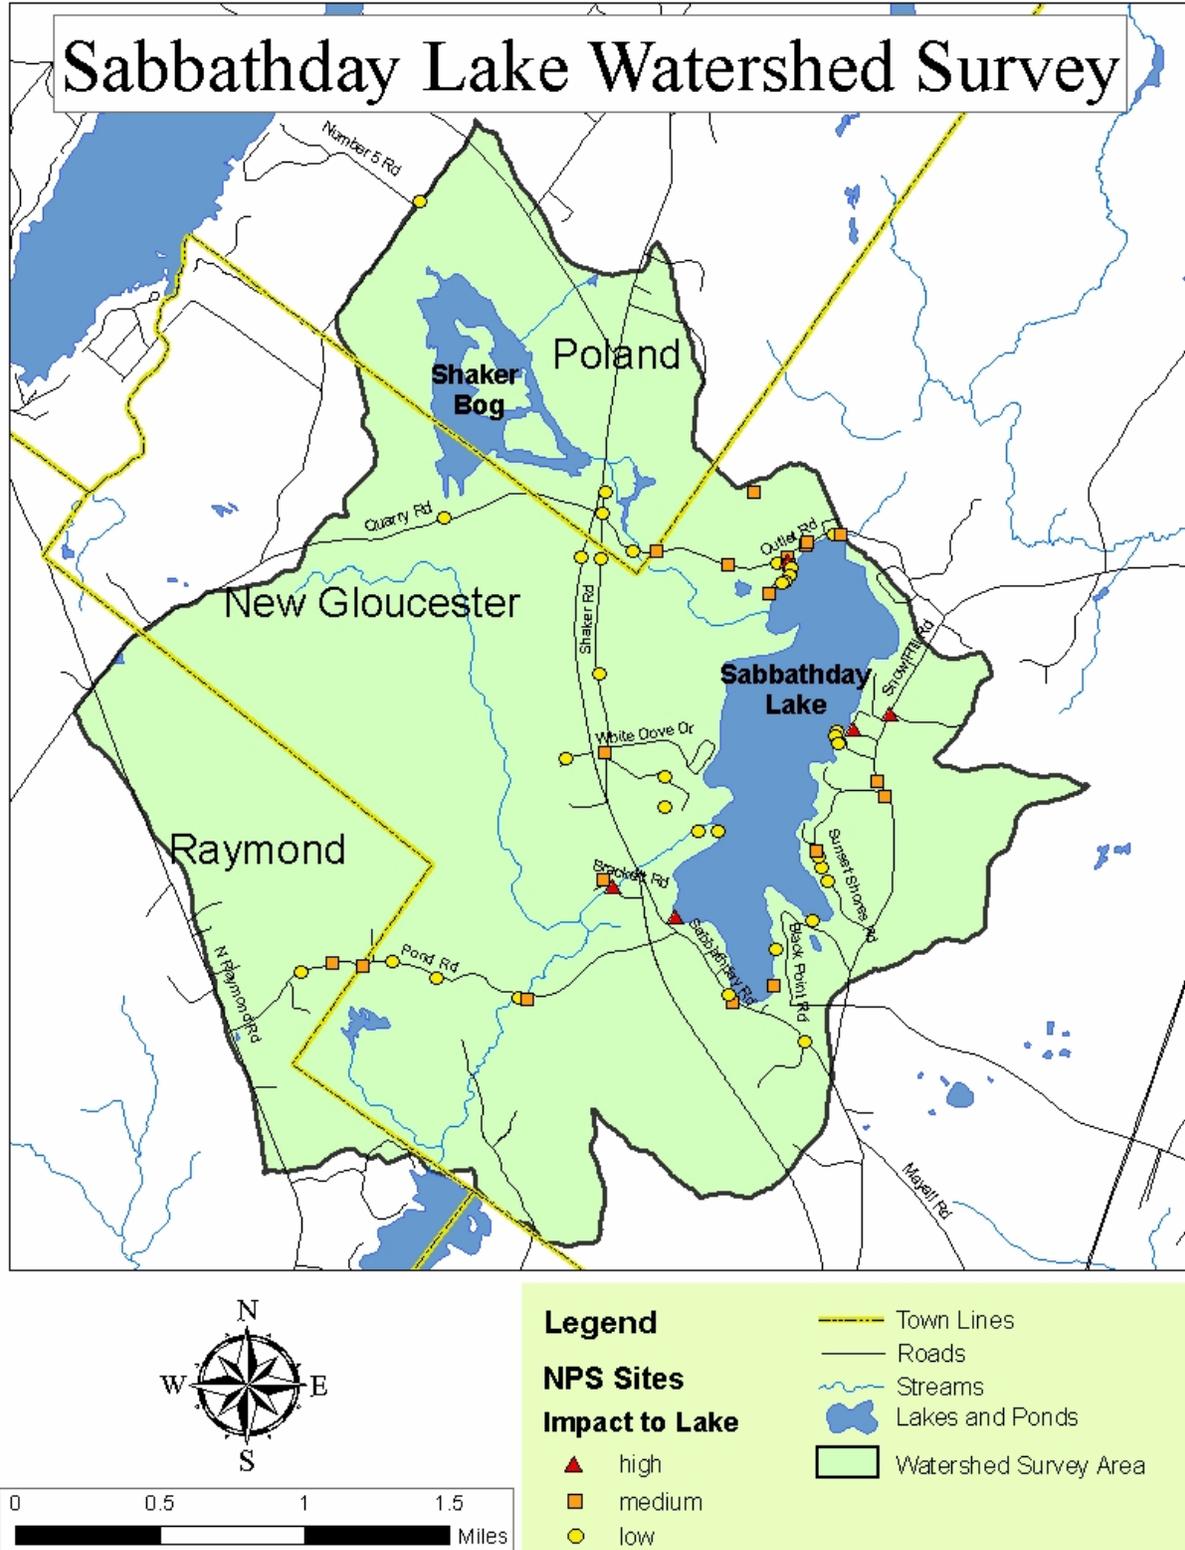
Figure 2. The Sabbathday Lake Watershed (5.33 square miles) with points representing the documented sites.

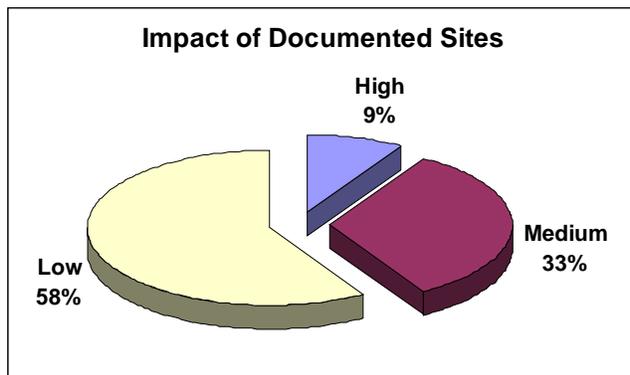
Figure 3.

**Impact** was based on size of site, slope, amount of soil eroded and proximity to water.

- “Low” impact sites are those with limited soil transport off-site.
- At “medium” impact sites, sediment is transported off-site, but the erosion doesn’t reach a high magnitude.
- “High” impact sites are large sites where there is significant erosion that flows directly into a Sabbathday Lake or a waterbody flowing into the lake.

More than half of all documented sites were ranked low impact. It is important to keep in mind that, when combined with many other similar sites throughout a watershed, even erosion from small sources can have a significant impact on lake water quality.

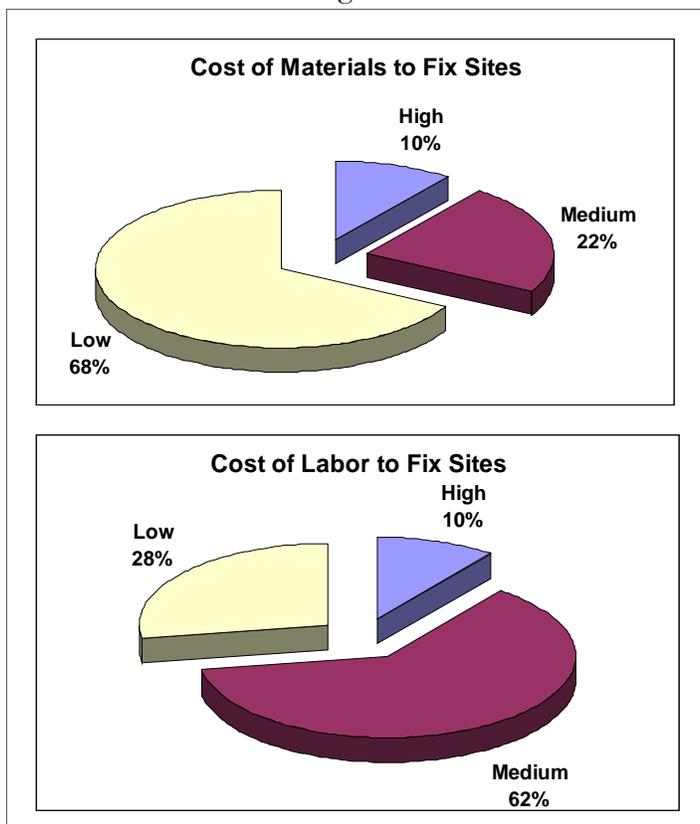
Figure 4.

**Cost** is an important factor in planning for restoration. It is useful to consider costs for materials and labor individually, so as to not miss any “hidden” costs.

- “Low” cost sites were estimated to cost less than \$500 to fix.
- An estimate of \$500 to \$2,500 was rated “medium”.
- If the estimated cost to fix a site exceeded \$2,500, a “high” rating was assigned.

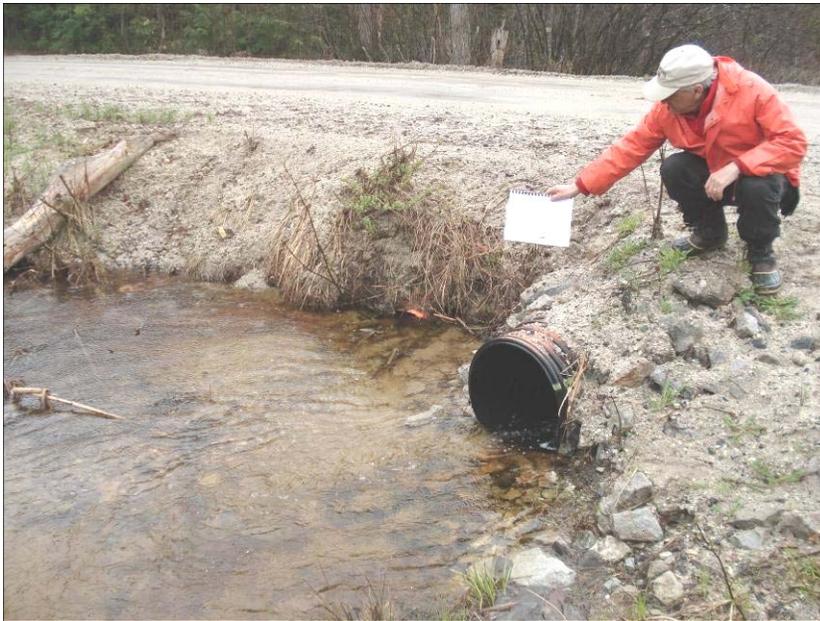
The erosion problems associated with the town road pictured below were common on many other roads throughout the watershed.

*(Sector and site number blocked from photos for generalization purposes.)*

- Clean out culverts and armor culvert inlets and outlets with riprap
- Vegetate or stabilize road shoulders
- Remove winter sand
- Replace clogged, rusted, or broken culverts
- Enlarge and lengthen culverts contributing to erosion
- Clean, reshape, and armor ditches with stone or vegetate with grass

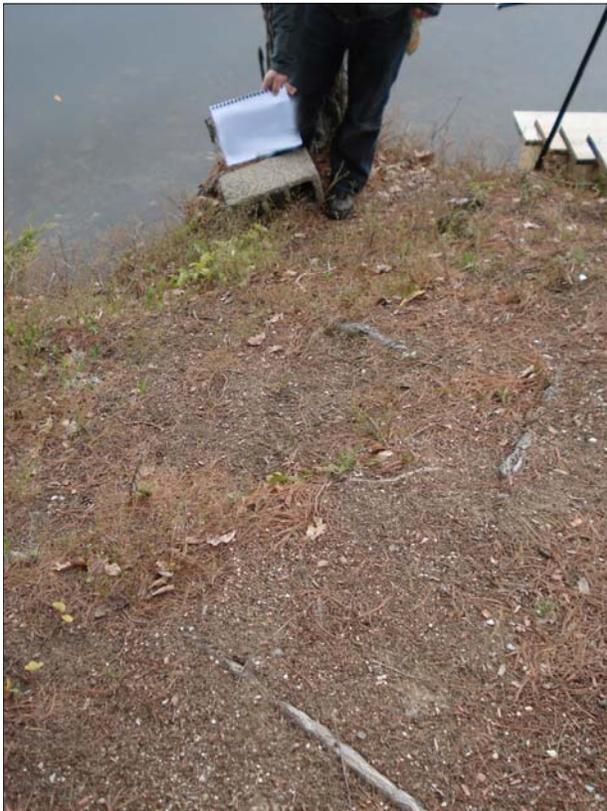
The erosion problems associated with the property pictured at left were common on many other properties within the watershed.

- Plant native plants.
- Mulch bare areas.
- Infiltrate or redirect runoff above shoreline.
- Stop raking.

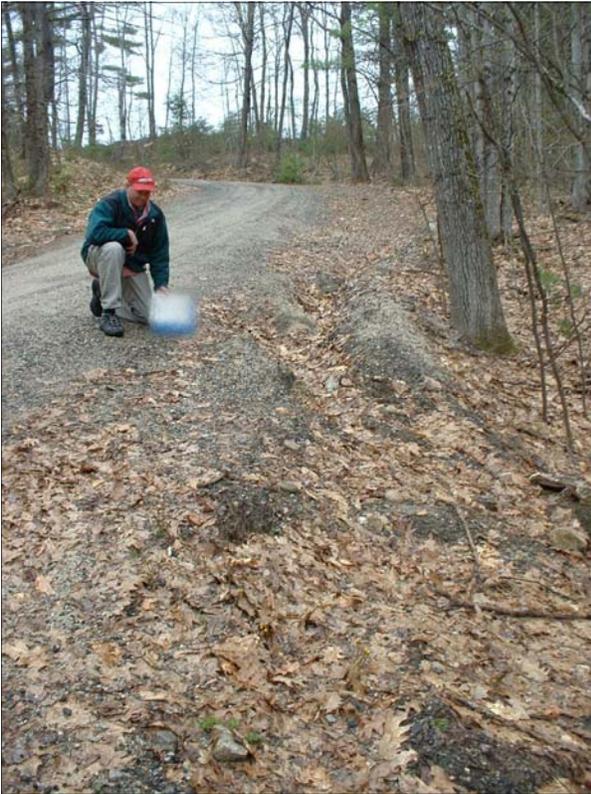
The erosion problems associated with the private road pictured below were common on many other roads within the watershed.

- Severe road shoulder erosion.
- Severe ditch erosion.
- Road surface erosion.
- Poor surface material.
- Direct flow of road material to stream.

- Add new / proper surface material.
- Reshape and crown road.
- Reshape and stabilize ditching.
- Install runoff diverters or turnouts to direct water to areas where it will infiltrate.
- Stabilize road shoulder with vegetation or stone.

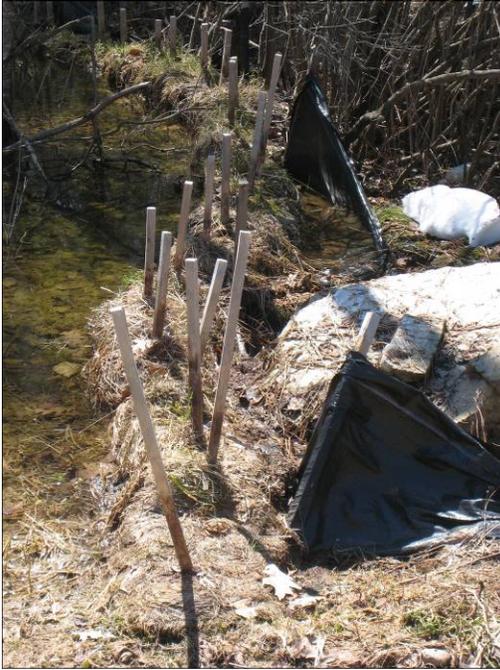
A collapsed silt fence observed at a construction site in the Sabbathday Lake Watershed.

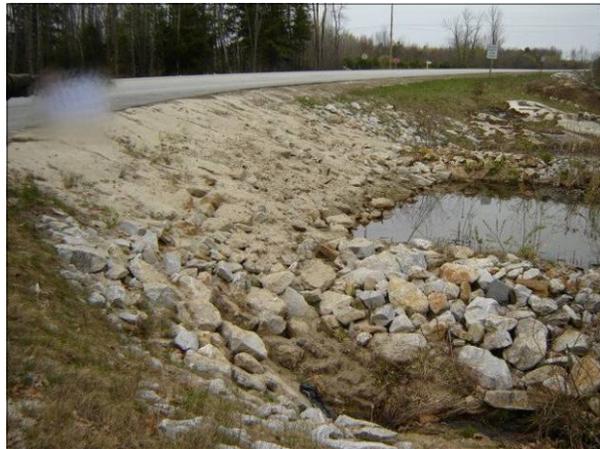
*Excess winter sand buildup can not only cause water quality problems, but can clog sediment basins and culverts used to filter and channel road runoff.*

The photo at right shows excess winter sand washing off a state road site. Winter sand buildup was common in this survey.

Three state road sites were documented, all of which were rated as low impact. These sites had similar issues to the town and private road sites, which included road shoulder erosion, bare soil, ditch erosion, and winter sand buildup. Recommendations for improving these issues include stabilizing road shoulders and ditching with vegetation or stone and removing winter sand build up.

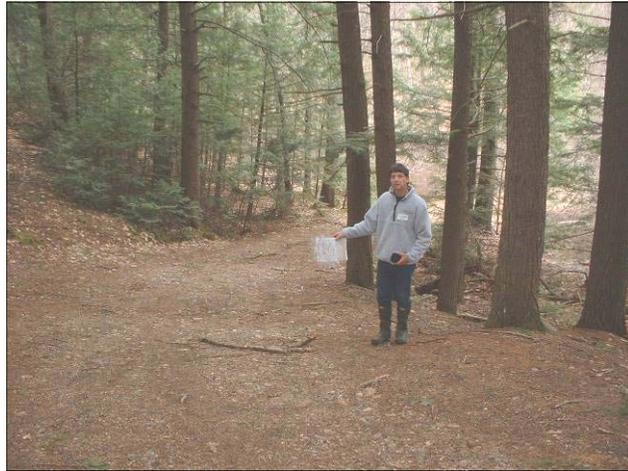
Two low impact driveway sites were documented in this survey. Both sites showed signs of moderate surface erosion. Like gravel roads, driveways also need to be created with proper road material and crowned in order to get the water off the surface quickly.

The photo at right shows a gravel driveway lacking a proper crown. This causes water to wash down the driveway leading to erosion problems.

***Preserve water quality and save time, money, and wear and tear on your vehicle by having a well crowned driveway. Use adequate surface material and add diverters to direct runoff into stable, vegetated areas.***

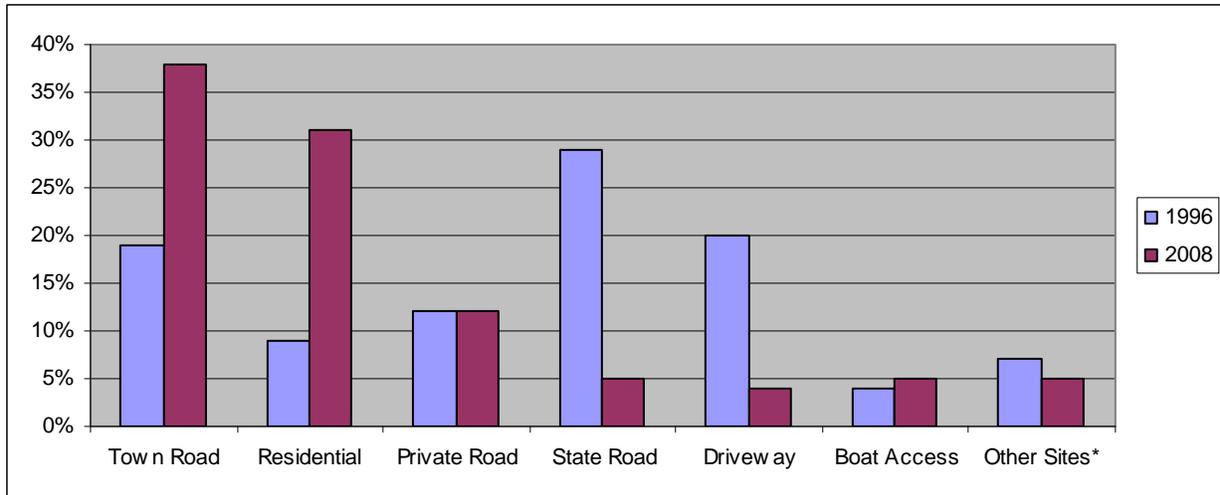
Figure 5.

## Percentages of Identified Erosion Sites by Land Use

\*Other sites include Beaches, Commercial, and Logging observed in 1996 and Agricultural, Commercial, and Beach Access observed in 2008.

In comparing data from both watershed surveys, 75 water quality impact sites were identified in 1996 whereas 58 were identified in 2008. In 1996, the majority of erosion sites identified were state roads, driveways, town roads and private roads. In 2008, the majority of erosion sites identified were town roads and residential properties (Please refer to Figure 5 above). Water quality impacts were observed at boat access and logging sites in 1996 and not in 2008 and impacts at agriculture and construction sites were observed in 2008 and not in 1996.

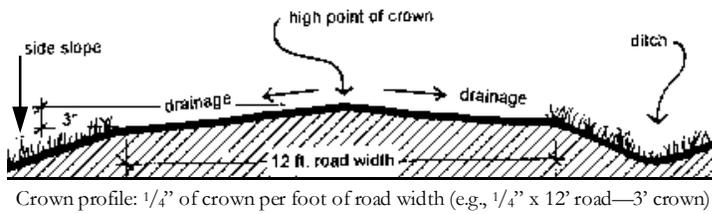
**Crown**—High point that runs lengthwise along the center of a road or driveway. The high point slopes gently away from the center toward the outer edge of the road, allowing water to drain off the road and preventing erosion of the road surface.

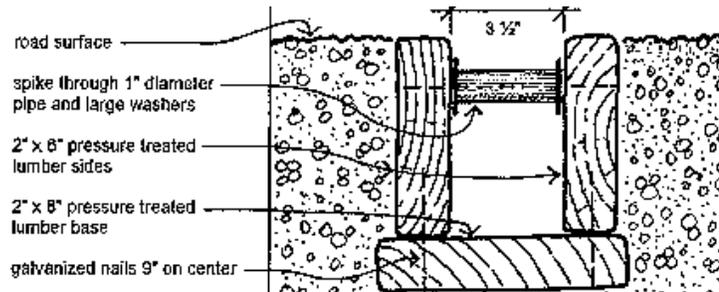
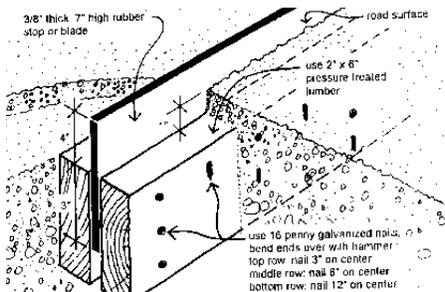
**Open Top Culvert**—Box-like structure that collects and diverts road surface runoff away from a sloped driveway or camp road. They are seldom recommended for year-round roads due to the likelihood of plow damage. Install at a 30° angle to the road and direct the outlet into a stable buffer. Clean out leaves and debris periodically.

**Rubber Blade**—Structure that protrudes above the road surface high enough to intercept and collect water, while allowing traffic to pass over it. It is generally not used on year-round roads and driveways because of the likelihood of plow damage. Install at a 30° angle to the road and direct the outlet into a stable buffer. The rubber conveyor belts can be purchased at some hardware stores or Portland Rubber Company (774-3993).

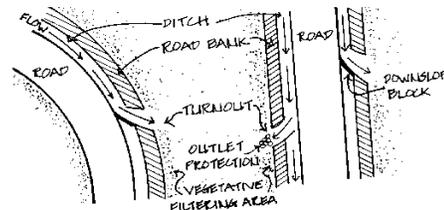
**Turnout**—A conservation practice used to direct runoff from a ditch (or road ruts) into a vegetated buffer. The turnout should have a flared end section that is level and lined with rock to spread out the flow.

**Waterbar**—Ridge (like a speed bump) that runs diagonally across a road, driveway or path, typically at a 30° angle. Stops water from running down the road and diverts it to the side. Easy to construct and most appropriate for roads with low traffic volume. Needs to be rebuilt periodically.

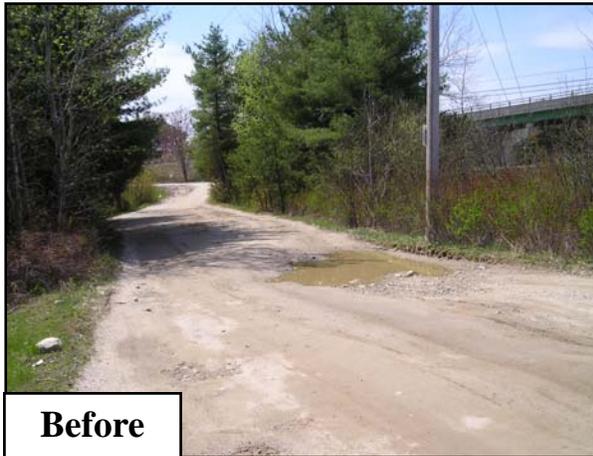
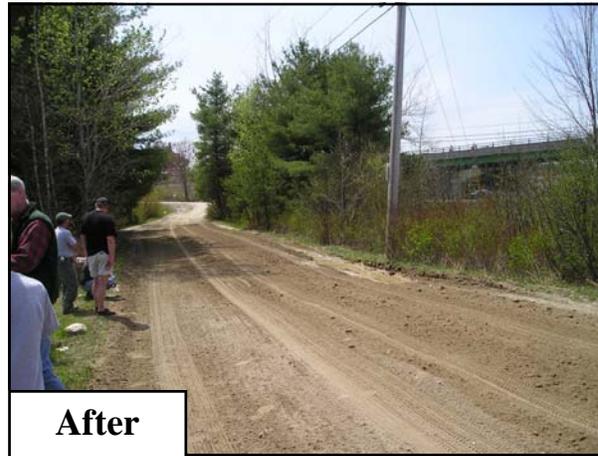
Above: Road association funding paid for grading to remove a large pothole on this private gravel road.
